**Flood Control Project Maintenance
Levee Inspections**

Maintenance Issue Types Only, Levee Inspection Report By Mile - Fall 2016

Sacramento Maintenance Yard Putah Creek

Waterway	Bank	Unit Miles	Inspection Start/End	Inspector
Unit No. 01 Putah Creek or North Levee	Left	8.79	09/15/2016 09/15/2016	Herman Phillips

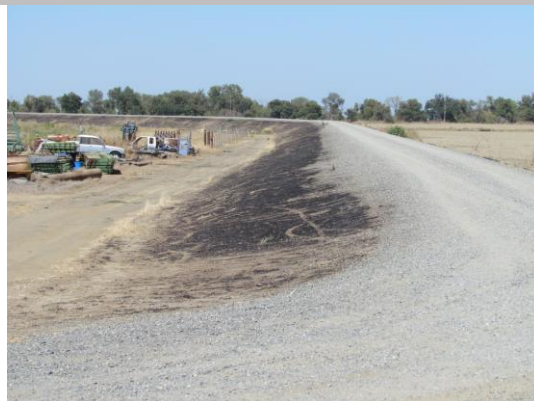
Photo 1 of 1 : FA_2016_ST0007_283_17_20161103_00021.jpg

LM Start	0.00	Rating **	A	Issue No.	17
LM End	3.93	Issue Type +	Ma	Location *	LS
Category	Earthen Levee			GPS Latitude/Longitude	
				Start	End
Item	Vegetation			38.504743 °	38.515648 °
				-121.663298 °	-121.727545 °
DWR ID	DWR_ST0007_02_f_2016_17				
Comment Code					
V1 : Control annual grass and weeds on the levee slopes and easements.					
Inspector Comment

Putah Creek looking downstream from levee mile 0.00 landside.

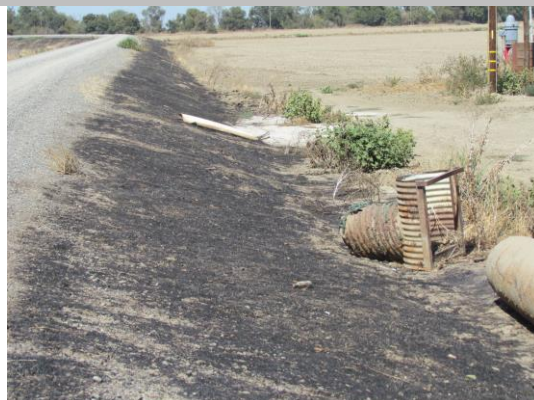
Photo 1 of 1 : FA_2016_ST0007_283_18_20161103_00022.jpg

LM Start	0.01	Rating **	M	Issue No.	18
LM End	0.01	Issue Type +	Ma	Location *	WS
Category	Earthen Levee			GPS Latitude/Longitude	
				Start	End
Item	Encroachments			38.504870 °	38.504870 °
				-121.663157 °	-121.663157 °
DWR ID	DWR_ST0007_02_f_2016_18				
Comment Code					
PI : Pipe					
Inspector Comment					
Remove the old discarded pipe from the levee section.

Putah Creek Unit 2 waterside levee mile 0.01.

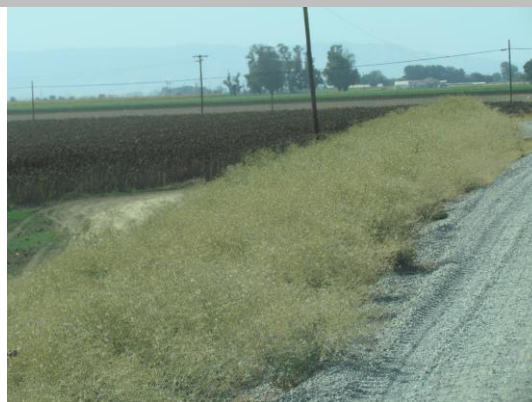
Photo 1 of 1 : FA_2016_ST0007_283_30_20161103_00030.jpg

LM Start	3.93	Rating **	U	Issue No.	30
LM End	4.03	Issue Type +	Ma	Location *	LS
Category	Earthen Levee			GPS Latitude/Longitude	
				Start	End
Item	Vegetation			38.515648 °	38.515693 °
				-121.727545 °	-121.729338 °
DWR ID	DWR_ST0007_02_f_2016_30				
Comment Code					
V1 : Control annual grass and weeds on the levee slopes and easements.					
Inspector Comment					
Remove the tall grasses on the landside sloe and toe.

Putah Creek Unit 2 levee mile 3.93-4.03 landside shoulder and slope..
